FRONT ELEVATION

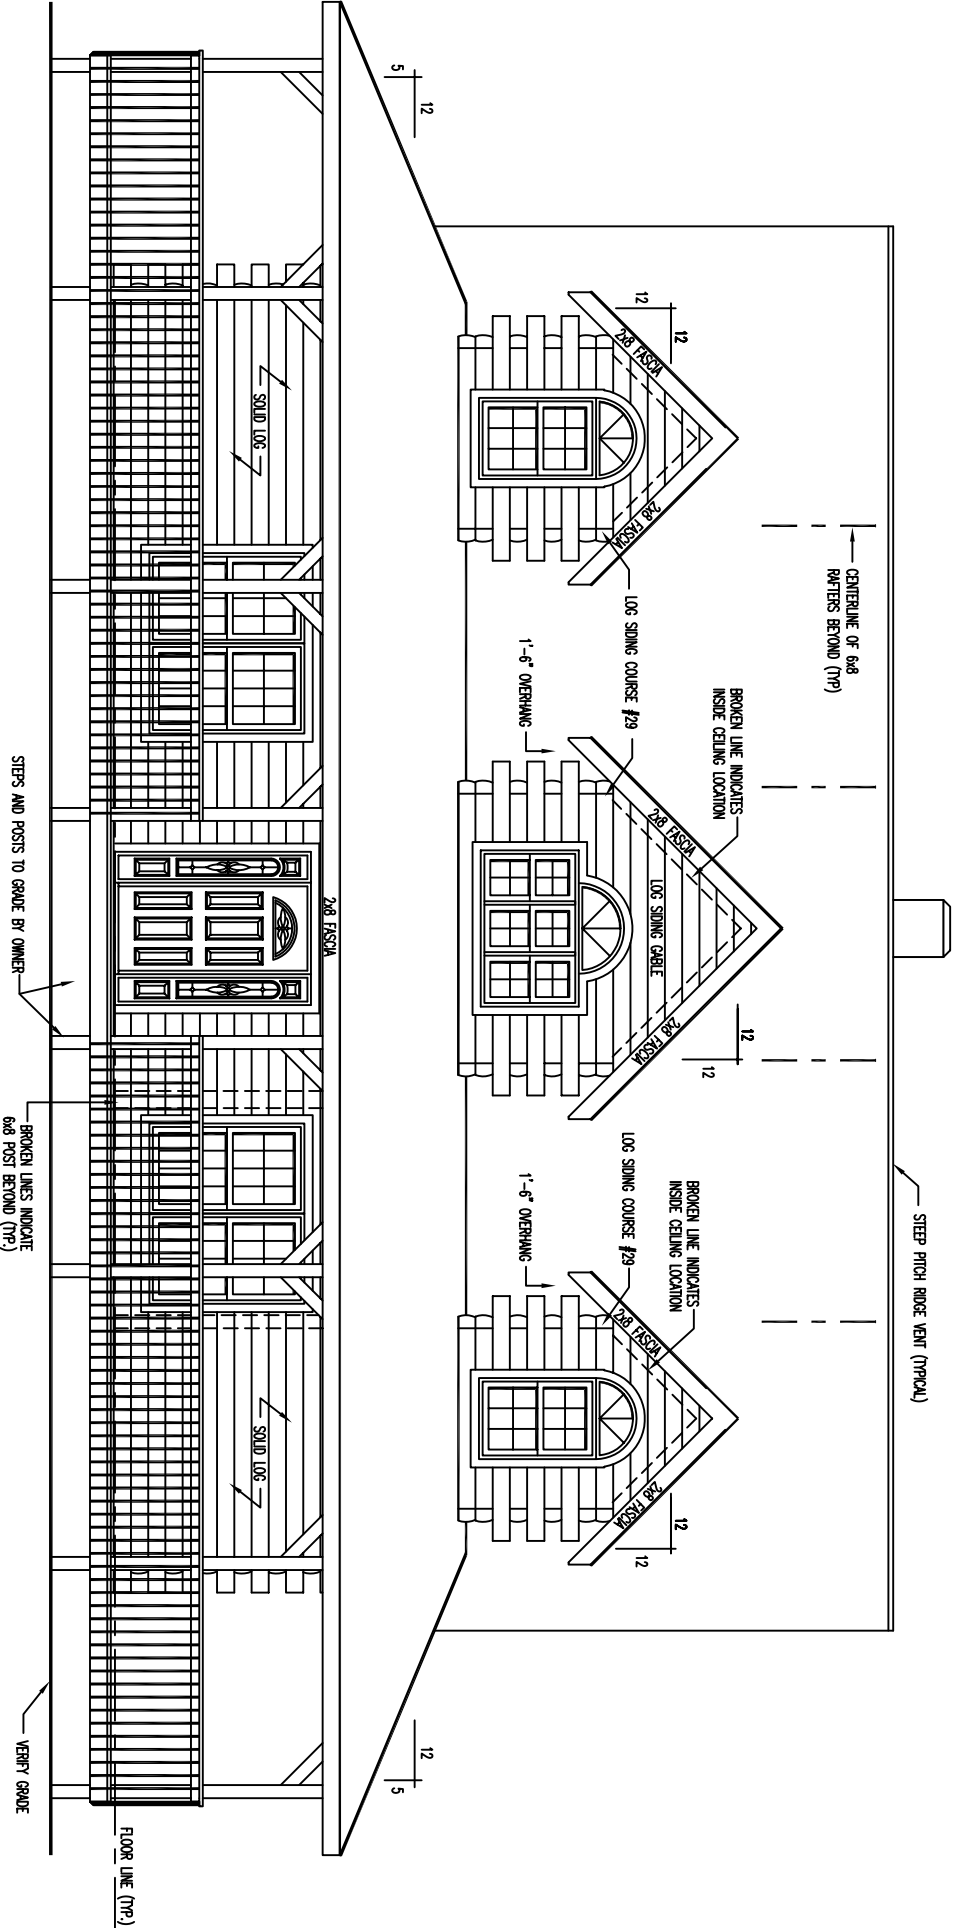
STEEP PITCH ROOF VENT (TYPICAL)

CENTERLINE OF 6x8 PARTERS BEHIND (TYP)

BROKEN LINE INDICATES INSIDE CEILING LOCATION

STEPS AND POSTS TO GRADE BY OWNER

BROKEN LINES INDICATE 6x8 POST BEHIND (TYP)

FLOOR LINE (TYP)

VERNEY GRADE

SOLID LOG

2x8 FASCI

LOG SINGING COURSE #29

1'-6" OVERHANG

LOG SINGING GABLE
